SAFETY MANUAL

**Dynamic Imaging Science Center
0.55 Tesla MRI**

**UNIVERSITY OF SOUTHERN
CALIFORNIA**

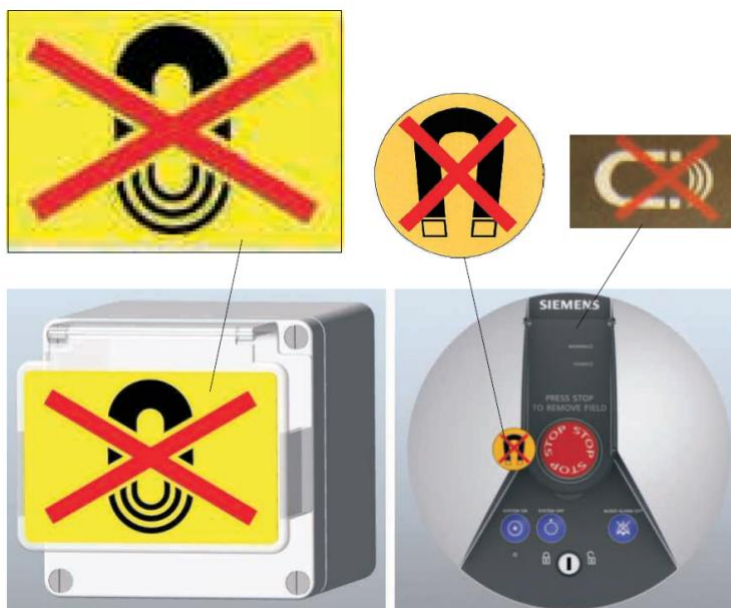
The device for initiating a quench, the **Emergency Magnet Stop** or Emergency Field Shut-down Unit (ERDU) button, pictured below, allows for the rapid reduction of the magnetic field in about 20 s from activation of the ERDU button to the moment when the magnetic field intensity in the magnet isocenter has dropped to 20 mT. There are two Magnet Stop switch available at the MR system:

1. an individual switch installed inside the examination room
2. an integrated switch built into the alarm box installed at the operator console.

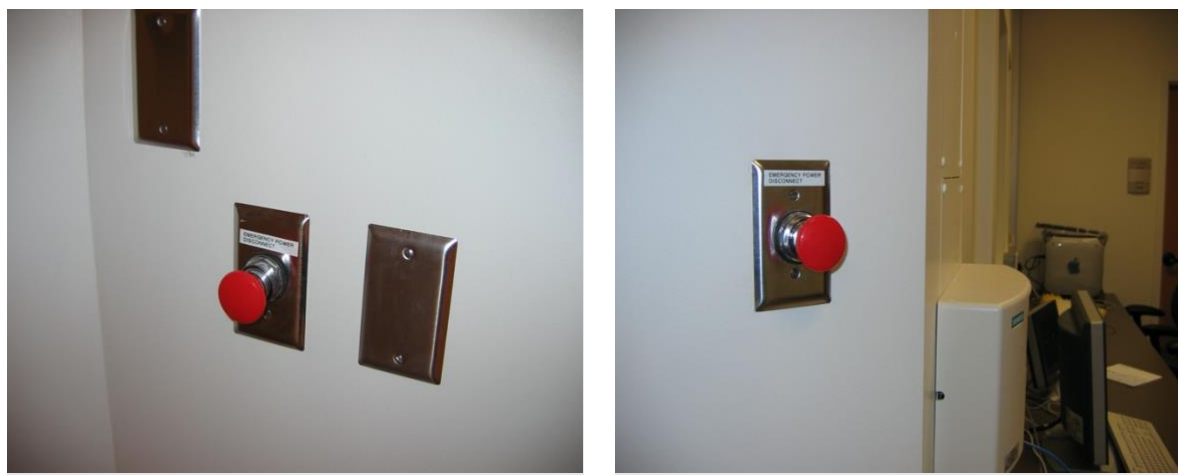
E. EMERGENCY OFF

The **Emergency Off** button pictured below is located on the wall in the MRI magnet room and on the operator's console. It removes ALL electrical power from the MRI console and the patient table, including any power sources from the Uninterrupted Power Supply (UPS) devices. The effect of pushing the Emergency Off button is to turn off the entire MR system, EXCEPT for the static magnetic field and the magnet quenching unit (described above), hence this **DOES NOT PRODUCE A QUENCH**. The button should only be used DURING A SERIOUS EQUIPMENT FAULT OR HAZARD, such as fire or water in the vicinity of the MR equipment.
